CASE STUDY SUMMARY

Application: Anti-fouling technique adopted in Eureka probes of the Ajman waters in UAE

Location: Ajman, UAE

Products used: Eureka Manta 3.5 Probes with Sutron GPRS Link Datalogger

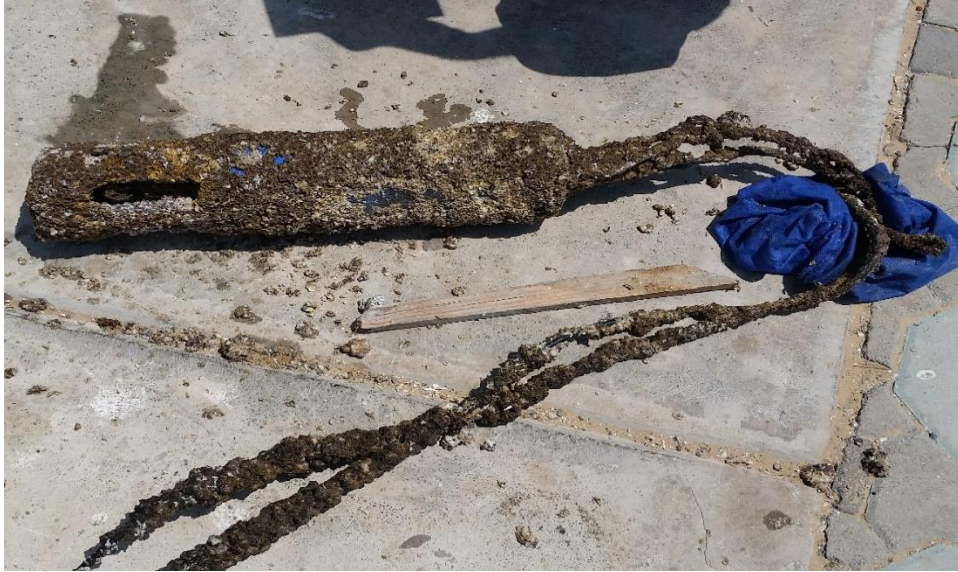
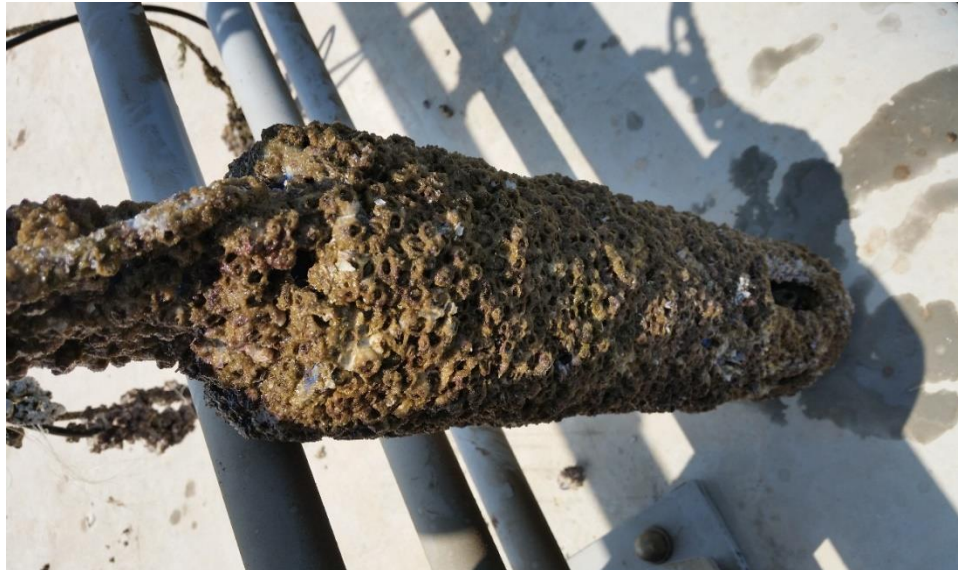
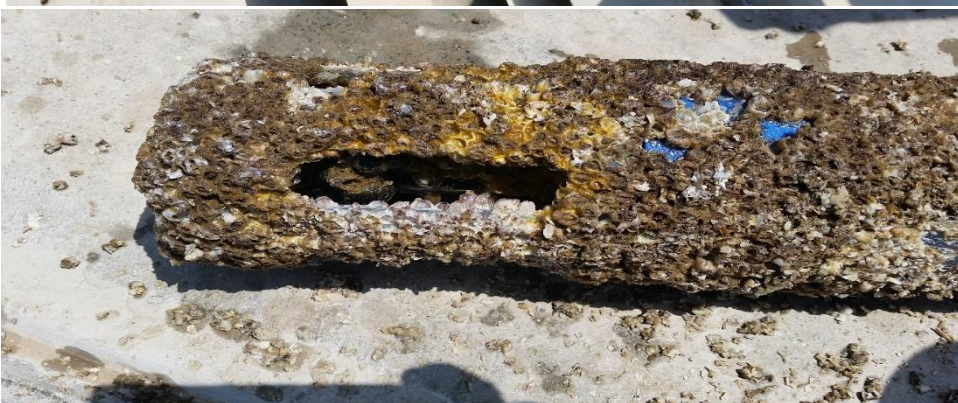
Without any anti-fouling precautions, either probes would have likely begun to experience drift by as soon as week 2 or 3 in this environment or sensors damaged within one month due to heavy saline condition and extensive growth.

Below pictures illustrates the condition of the probe without anti fouling techniques

ELARD adopted series of measures to solve the problems related with bio fouling issues and reduce the growth of biological organisms on instruments by following below techniques

We used Eureka supplied copper mesh to wound around the sensor guard to avoid strong growth on the sensors which may even eat up the epoxy of the sensor body

This will protect the probe body and help us cleaning the equipment quicker. We always recommend to use proper safety tools while performing the task

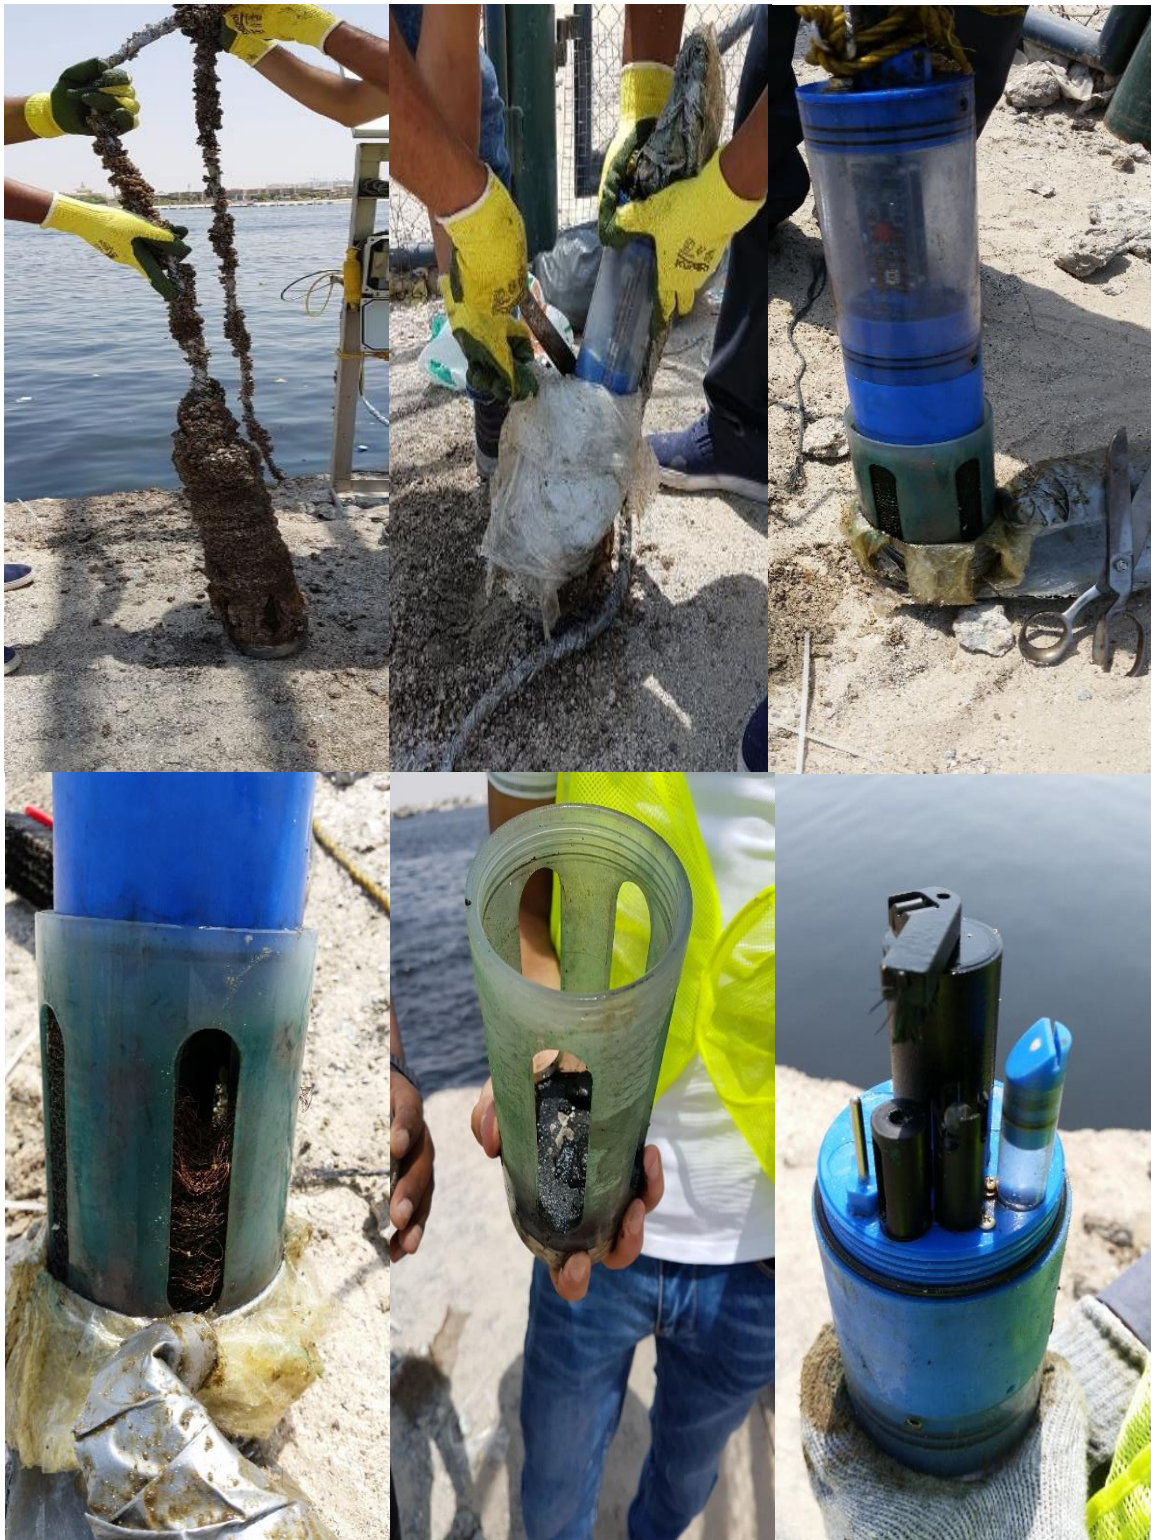
The Probes which is equipped anti-fouling components performed well over a 30 days deployment and we observed that the probe was performing well, without any signs of bio fouling accumulation on sensors and drift in values.

Below pictures illustrates the condition of the probe after anti fouling techniques are removed
